**WETLAND DELINEATION AND
JURISDICTIONAL DETERMINATION REPORT
FOR THE
MTD SITE (APNs 67-230-026, 59-140-004,-005,-006)
4678 CALLE REAL, SANTA BARBARA COUNTY, CALIFORNIA**

May 2018

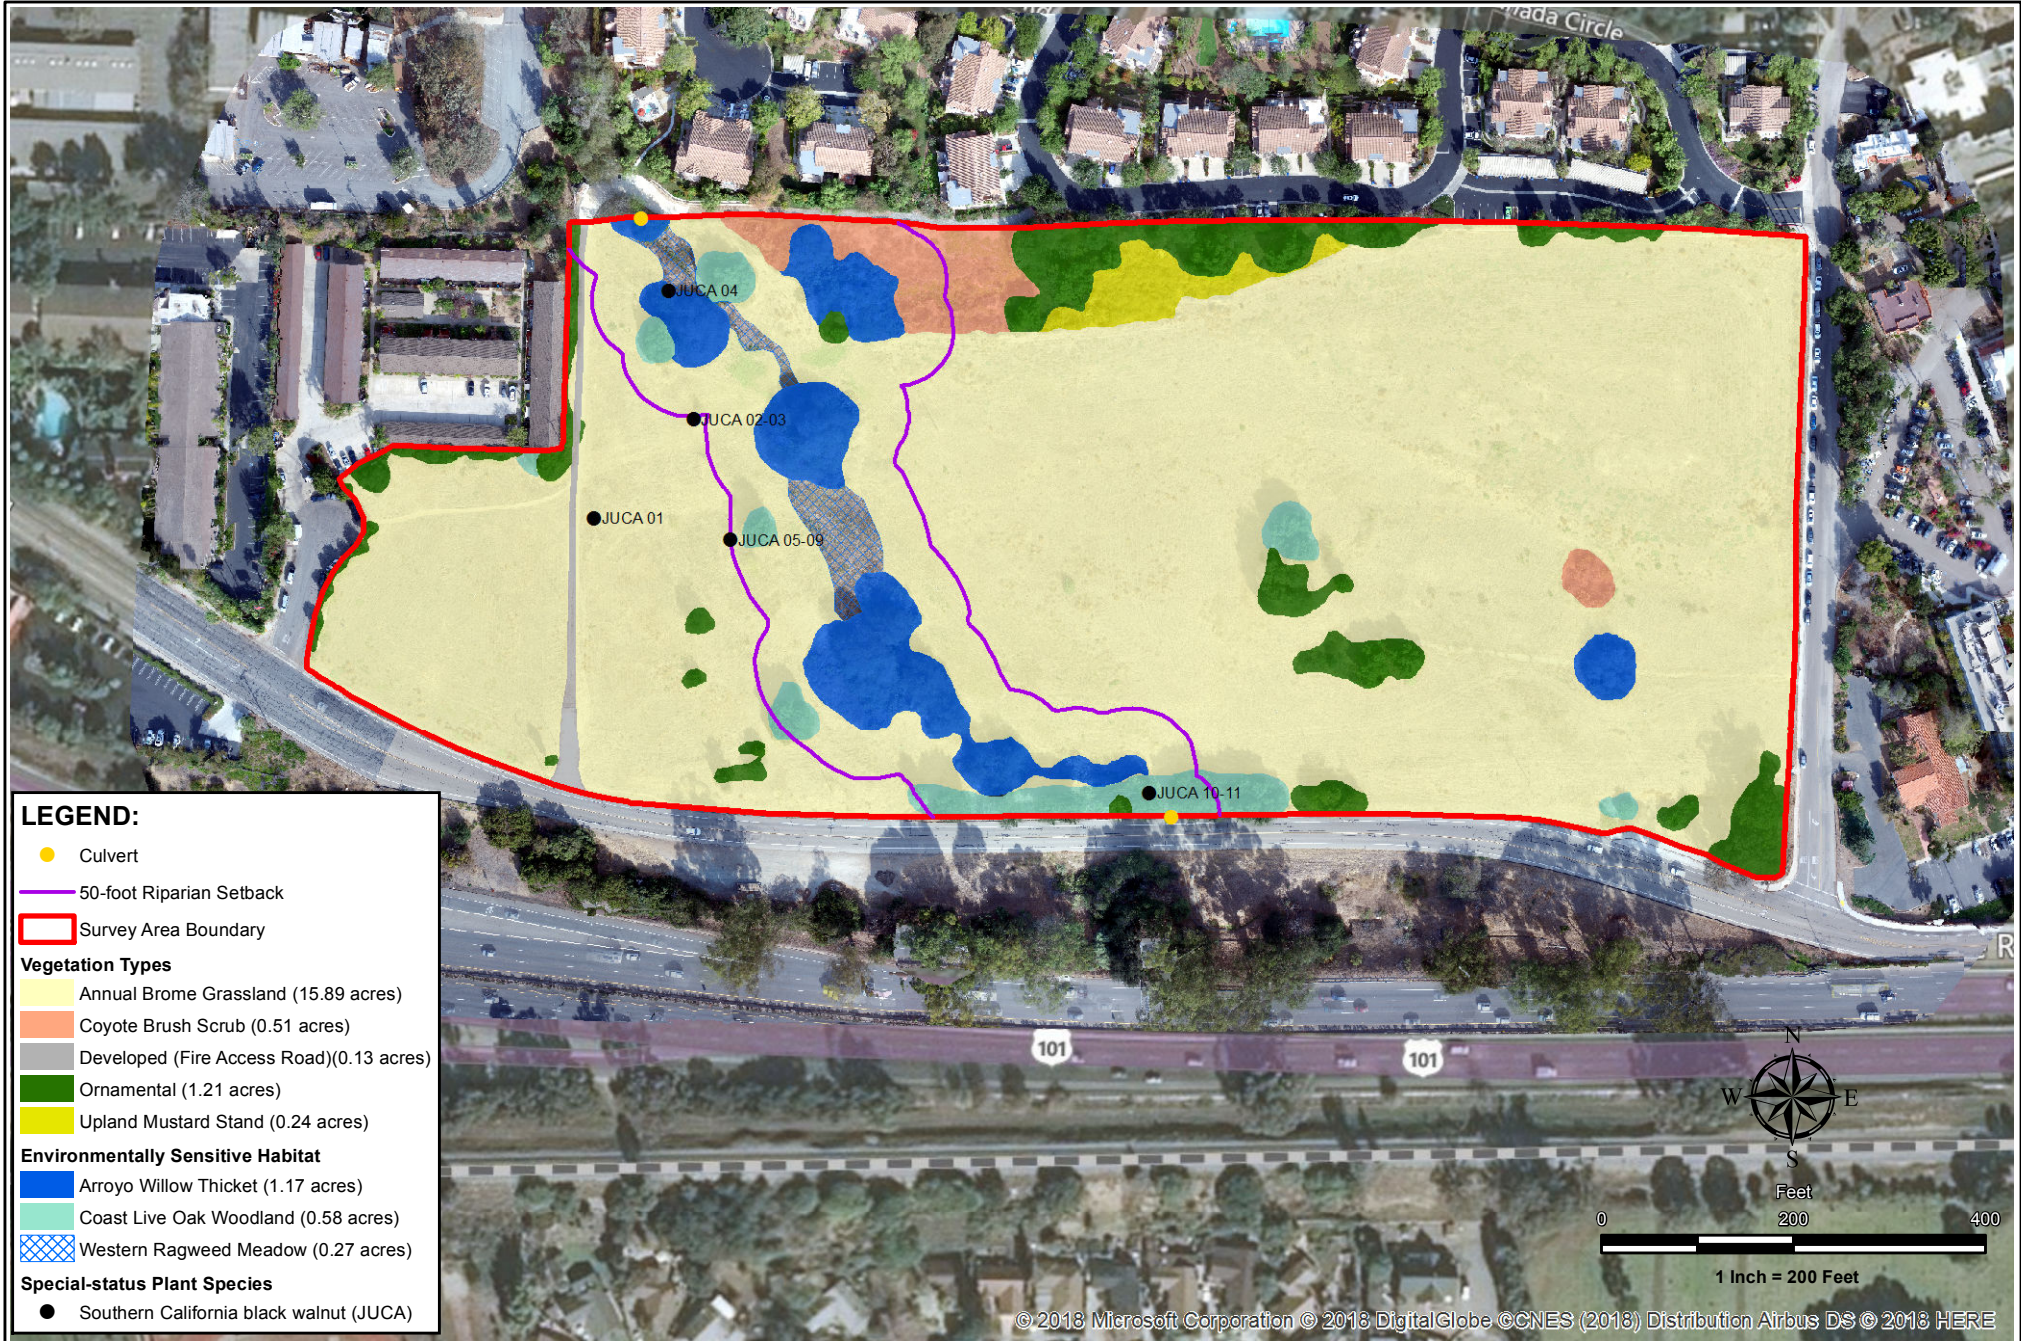
Soils pits were excavated and data were collected at nine sampling points within the Survey Area (see Appendix B – Wetland Data Forms, Figure 5 – Jurisdictional Waters and Wetlands Map). Waters/wetlands in the Survey Area are depicted in Figure 5 and described in detail below.

The area of USACE-jurisdictional waters of the U.S. extends to the OHWM on the banks of the northern and southern erosion features (0.20-acre) (Figure 5 – Jurisdictional Waters and Wetlands Map).

The majority of the Survey Area is comprised of Milpitas-Positas fine sandy loam, a moderately well drained sandy soil with an underlying restrictive clay layer that forms on moderately sloped terraces (9 to 15 percent slope) (NRCS 2017). Runoff can be of moderate concern due to the low permeability of the underlain clay layer. Milpitas-Positas fine sandy loam is present at SP08, which is located in the swale that receives runoff from N. San Antonio Road in the southeastern portion of the Survey Area (Figure 5 – Jurisdictional Waters and Wetlands Map).

The central portion of the Survey Area consists of Elder sandy loam and encompasses the drainage and associated waters/wetlands. Elder sandy loam is a well-drained soil derived from alluvium that forms on relatively flat landforms (alluvial fans, floodplains, and inset fans) (NRCS 2018). Elder sandy loam is present at SP01-SP07 and SP09 (Figure 5 – Jurisdictional Waters and Wetlands Map).

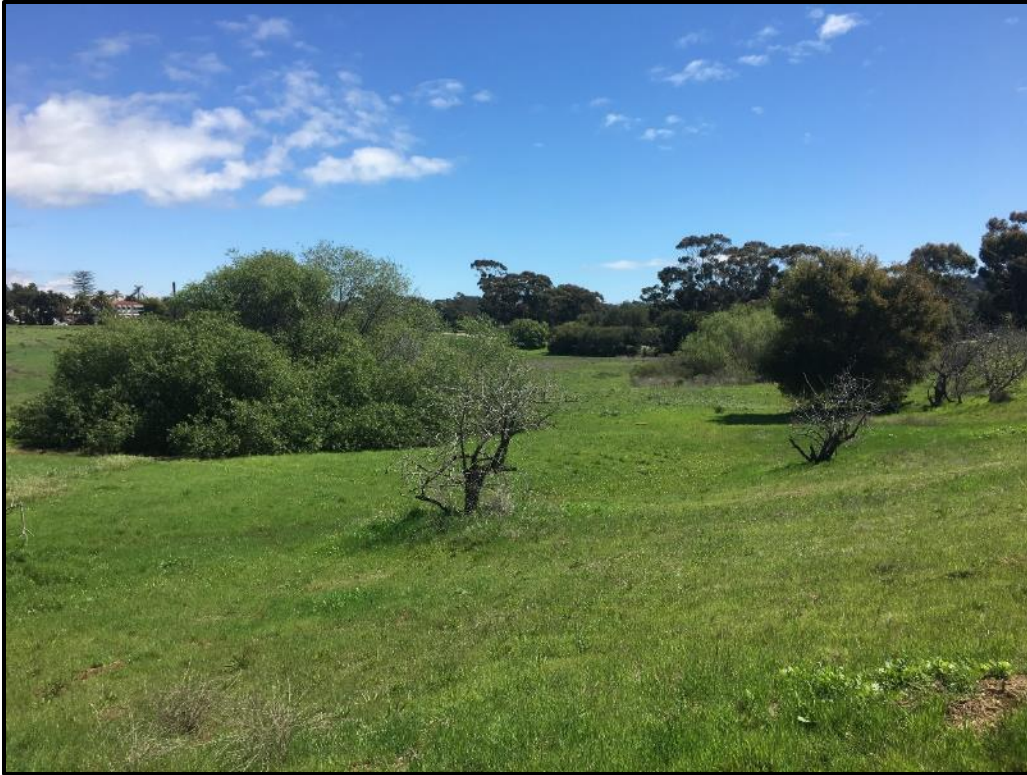
Photo 1. View of the drainage from the northwest corner of site (Aspect: Southeast). Photo taken March 23, 2018

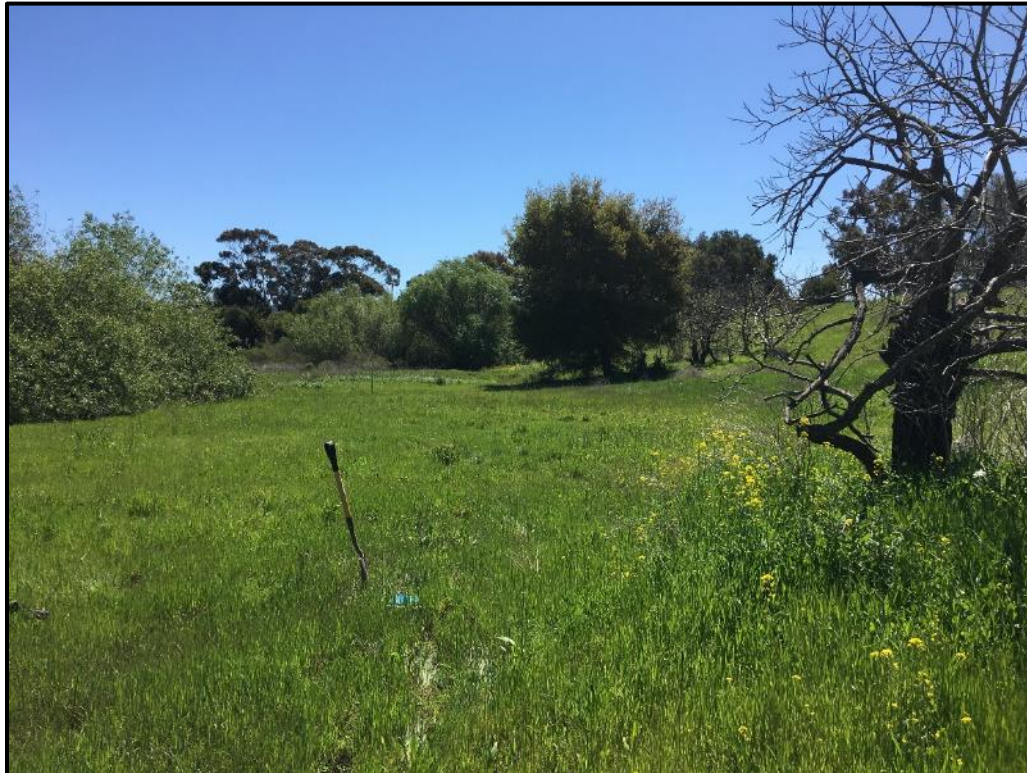
Photo 2. Sample Point SP01 located along the eastern side of the drainage adjacent to a southern California black walnut (Aspect: Northeast). Photo taken March 27, 2018.

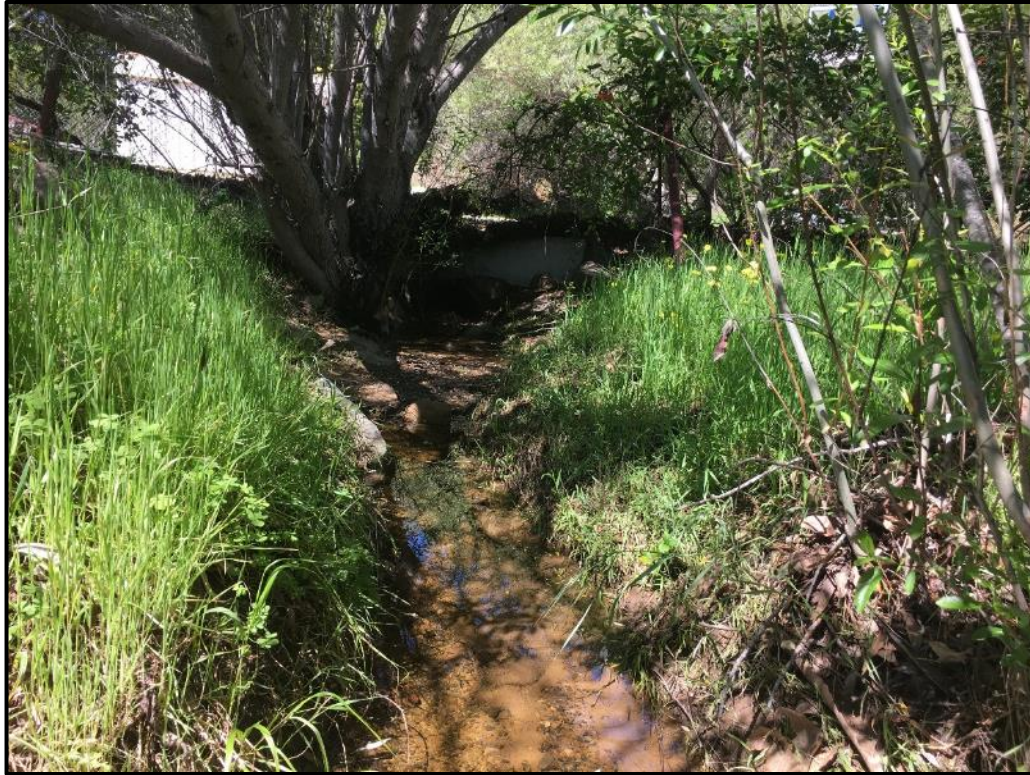
Photo 3. Culvert on the northern Survey Area boundary that receives runoff from the residential neighborhood (Aspect: North). Photo taken March 23, 2018.

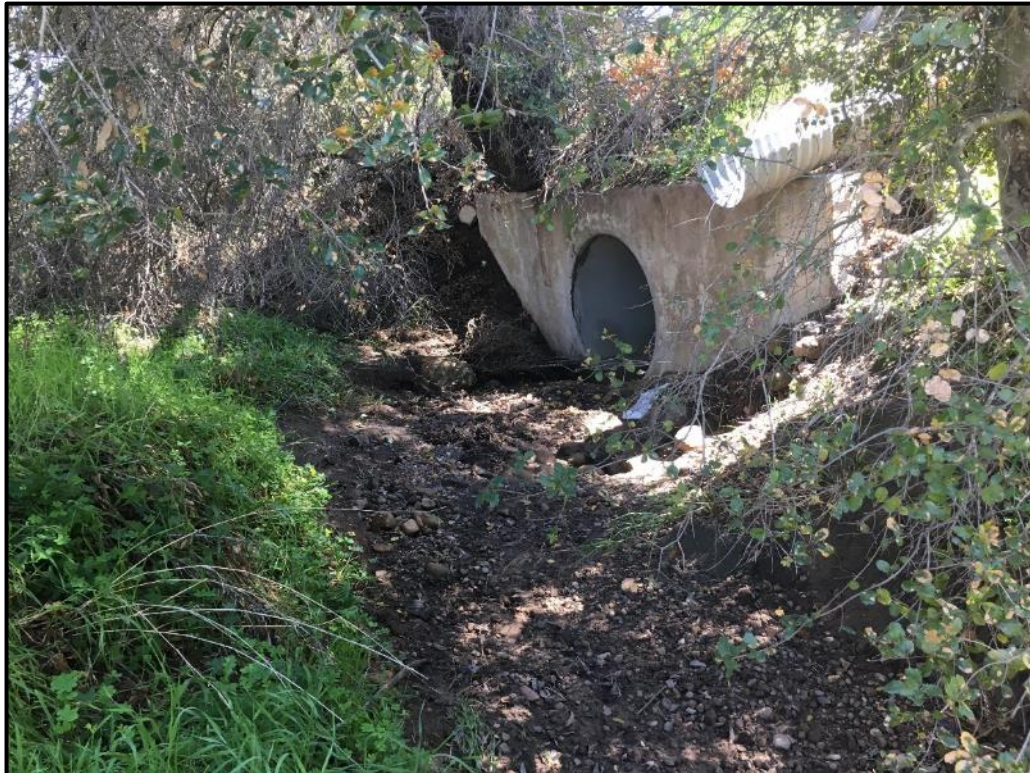
Photo 4. Culvert at the south end of the drainage that conveys runoff under Calle Real and Hwy 101 to Hospital Creek (Aspect: Southeast). Photo taken March 23, 2018.

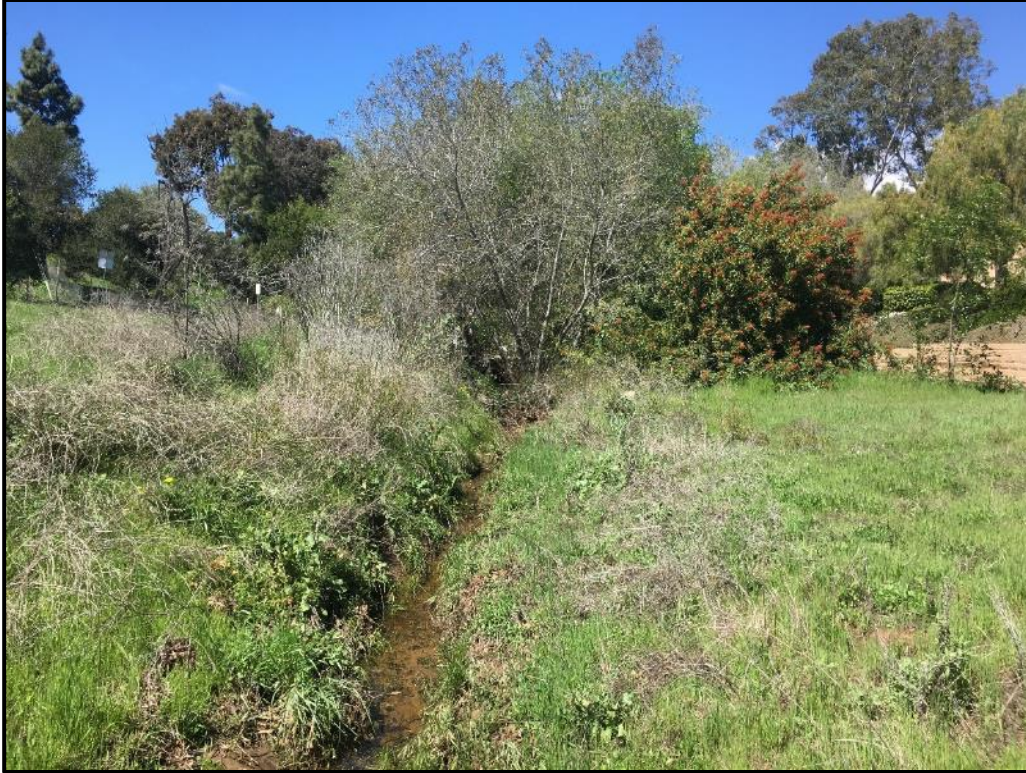
cobble. One (1) to 4 inches of standing water was observed in the channel in the northern erosion feature on March 23, 2018, approximately 24 hours after a storm event (Appendix A – Site Photographs).

Photo 5. Eroded channel in northern portion of drainage (Aspect: North). Several inches of standing water was present 24 hours after a rain event. Photo taken March 23, 2018.

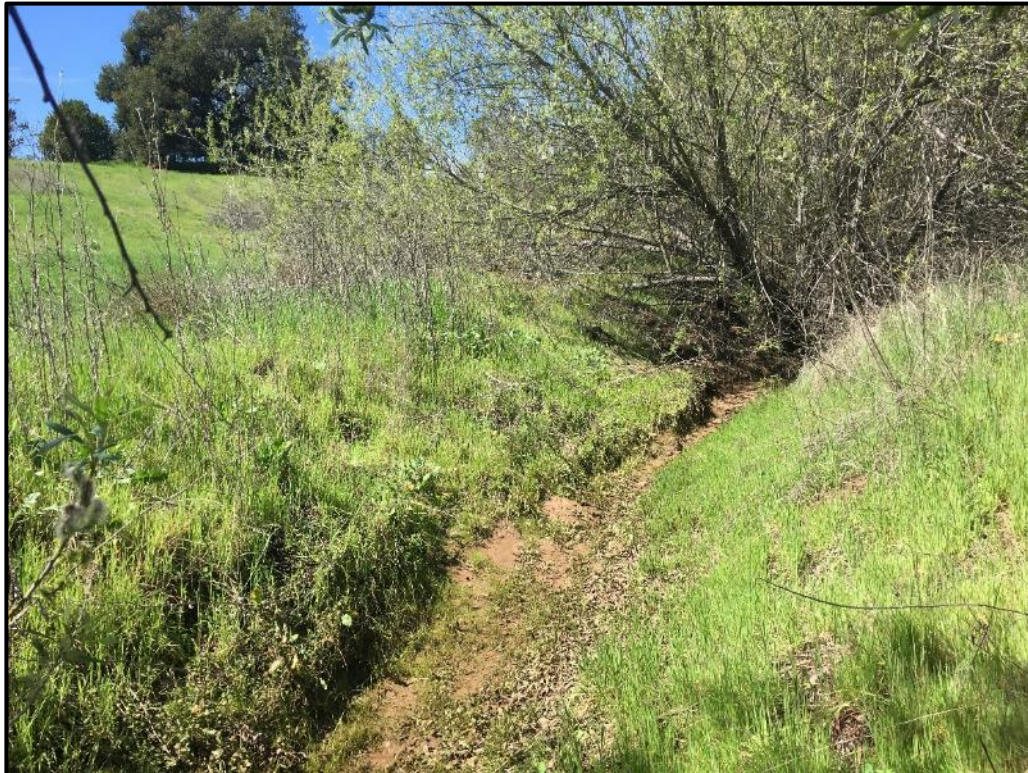
The channel in the southern erosion feature is approximately 370 feet long and ranges from 3 to 6 feet wide and 12 to 36 inches deep at the OHWM. The banks are incised to moderately sloped and range from 4 feet to 10 feet in height and the channel bottom consists of sediment and cobble (Appendix A – Site Photographs). Evidence of flow (debris racking and drainage patterns) was observed in the channel in the southern erosion feature on March 23, 2018, but no standing water was present.

Photo 6. Channel in southern erosion feature (Aspect: Northwest). Drainage patterns and debris racking were evident in channel. Photo taken March 23, 2018.

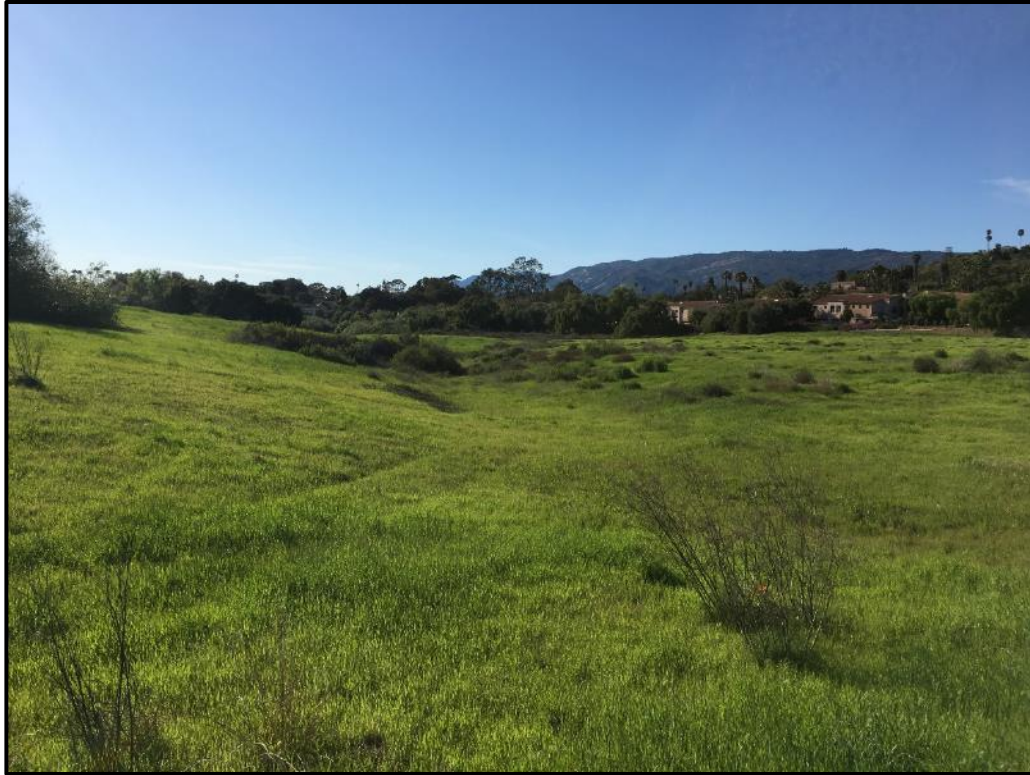
Photo 7. Swale in southeast corner of the Survey Area that receives runoff from N. San Antonio Road (Aspect: West). Photo taken March 27, 2018.

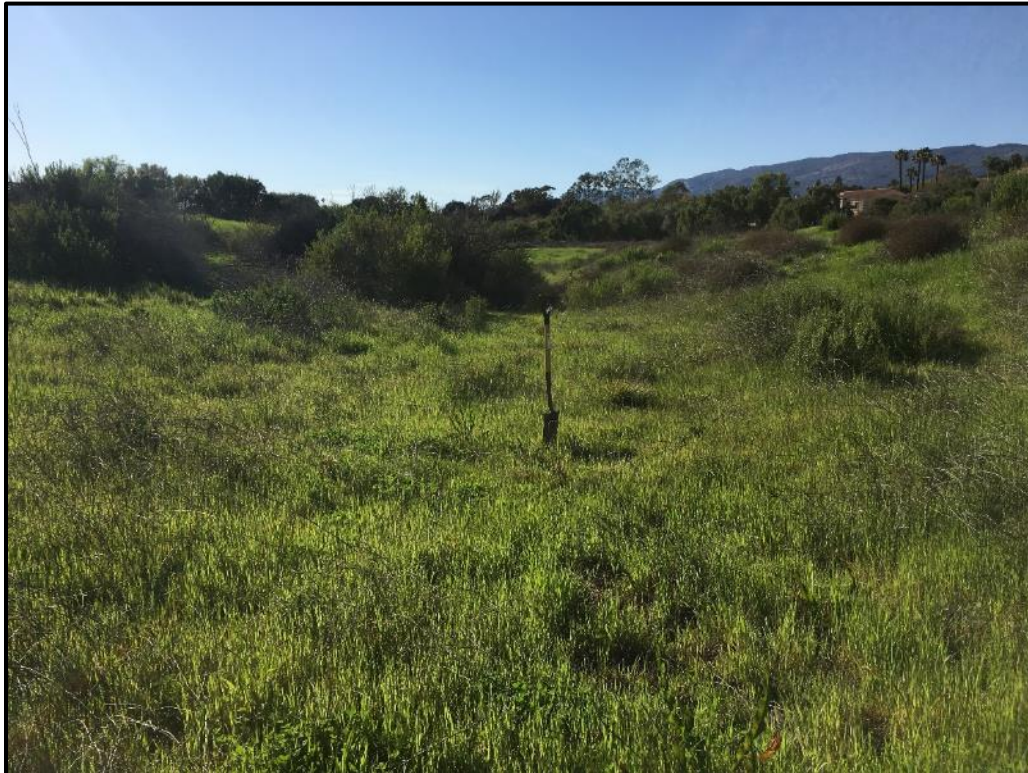
Photo 8. Sample Point SP08 located in swale off N. San Antonio Road (Aspect: West). Photo taken March 27, 2018.

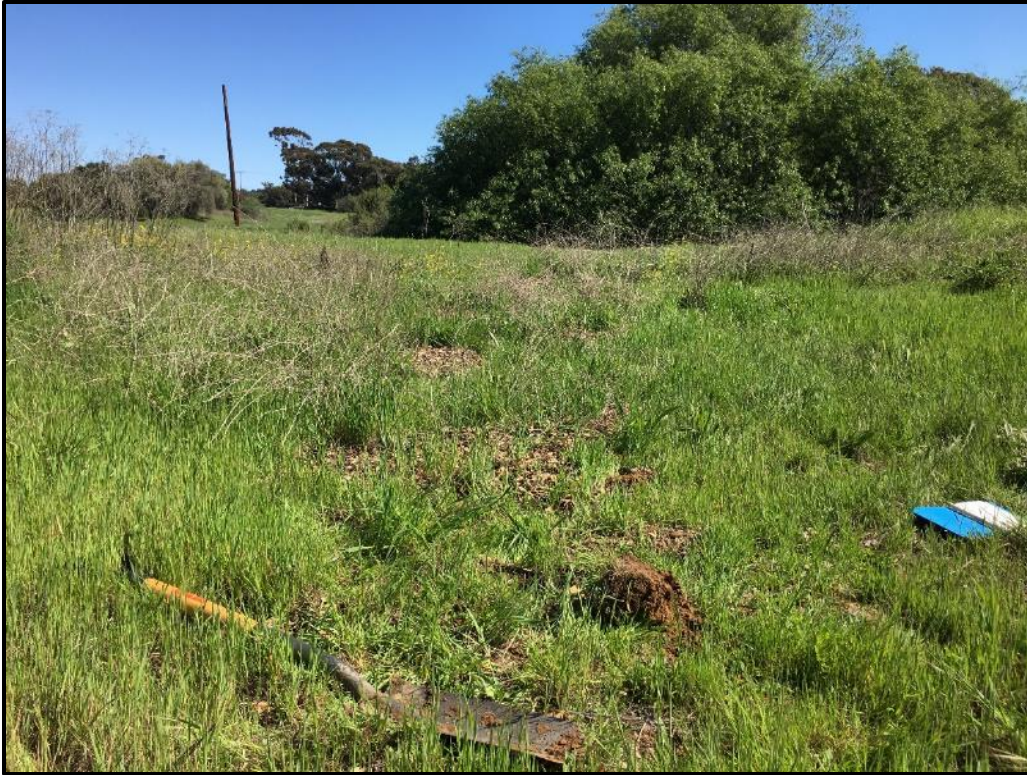
A primary indicator of wetland hydrology (drift deposits) was observed at three of the nine wetland Sample Points (SP02, SP07, SP09) (Appendix A – Site Photographs). Therefore, portions of the drainage the meet the County wetland definition based on this one criterion. Drift deposits (e.g., oak leaves, twigs, etc.) were observed at all three locations and drainage patterns were also evident at SP02. The lateral extent of County wetlands was delineated based on presence of these hydrology indicators (0.27-acre).

Photo 9. Sample Point SP07 located in the County wetland (Aspect: South). Drift deposits (oak leaves, twigs) visible behind soil pit and shovel. Photo taken March 27, 2018.

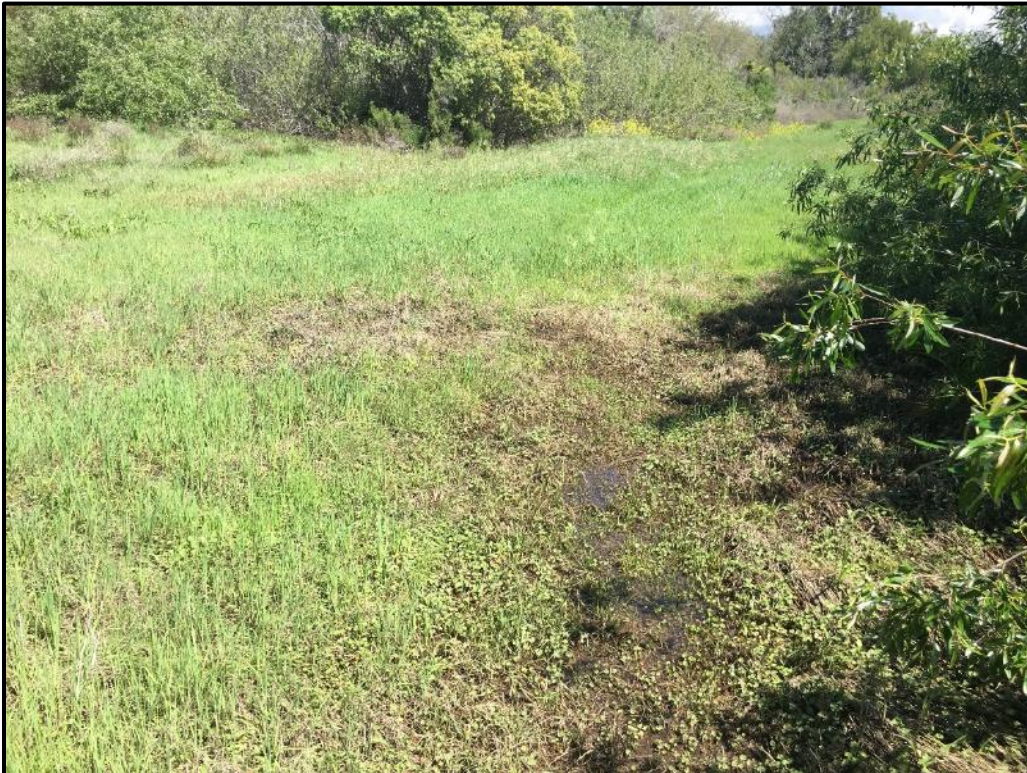
Photo 10. Standing water observed at Sample Point SP02, located in the County wetland, 24 hours after a storm event (Aspect: Southeast). Photo taken March 23, 2018.

Remarks: Two inches of standing water observed at SP02 on 3/23/18 following storm event on March 20-22. Drift deposits and drainage patterns evident, vegetation bent over by water/flow.

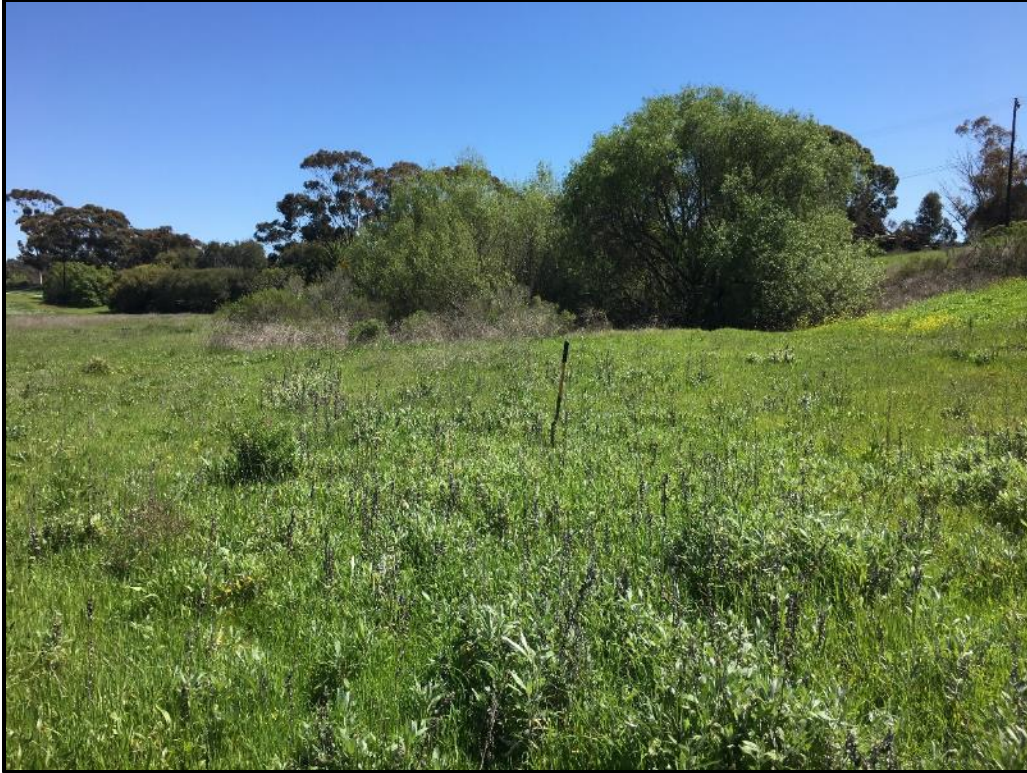
Photo 11. Sample Point SP04 located in a patch of mugwort in the central portion of the drainage (Aspect: North). No wetland indicators were observed. Photo taken March 27, 2018.

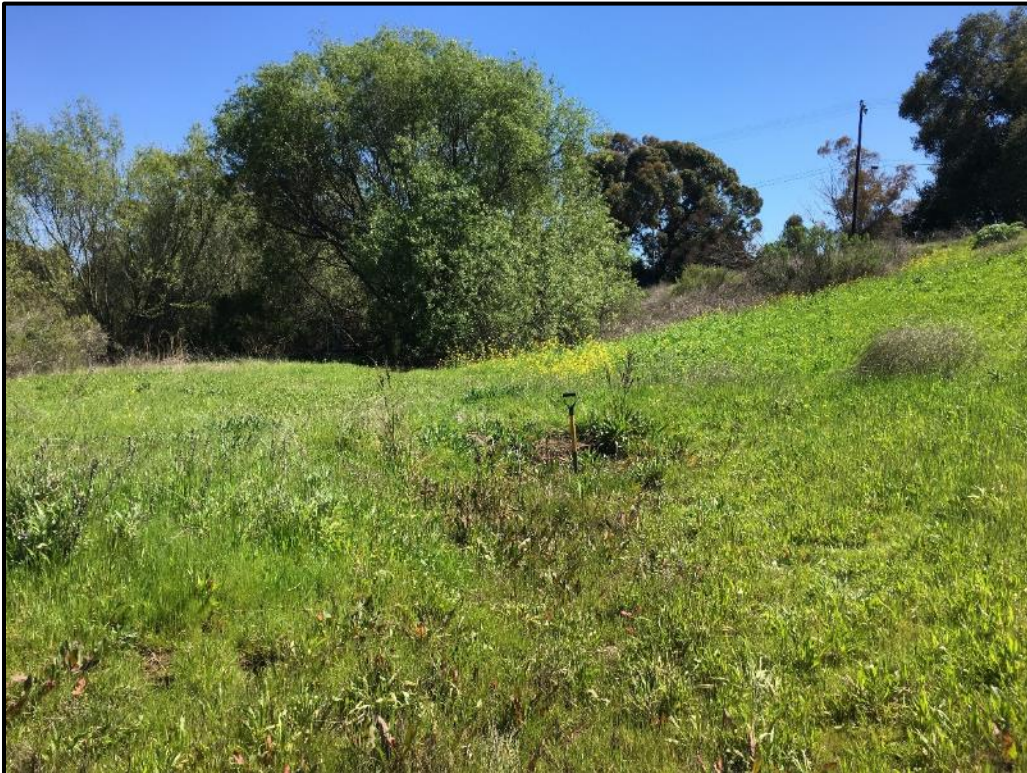
Photo 12. Sample Point SP05 during wetland data collection 5 days after a storm event (Aspect: North). No wetland indicators were observed. Photo taken March 27, 2018.

Remarks: Ponded water observed at SP05 on 3/23/18 following storm event; small depression holds water temporarily after rain events.

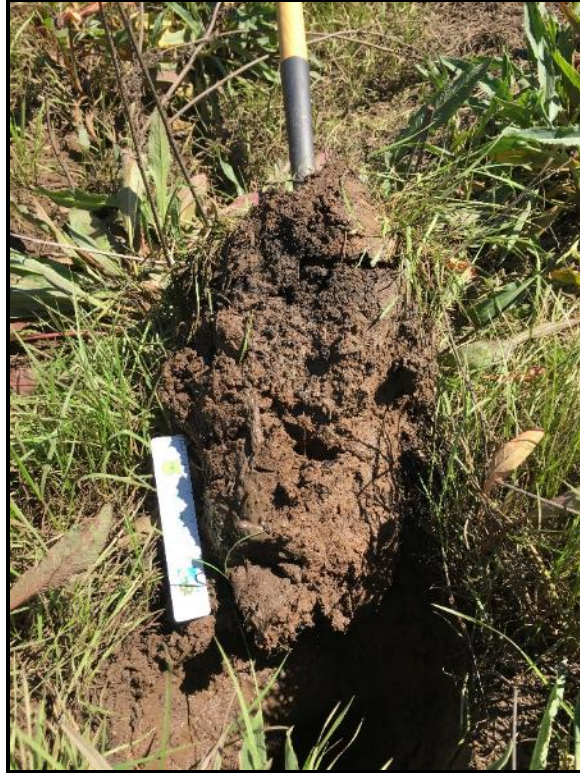
Photo 13. Soil excavated from SP05. Soil color was dark brown (10YR 3/3) with moderate sand content. Photo taken March 27, 2018.

Depth (inches)	Matrix		Redox Features				Texture	Remarks
	Color (moist)	%	Color (Moist)	%	Type ¹	Loc ²		
0-16	10YR 3/3	100	_____	_____	_____	_____	sandy loam	moderate sand content
_____	_____	_____	_____	_____	_____	_____	_____	_____
_____	_____	_____	_____	_____	_____	_____	_____	_____
_____	_____	_____	_____	_____	_____	_____	_____	_____
_____	_____	_____	_____	_____	_____	_____	_____	_____
_____	_____	_____	_____	_____	_____	_____	_____	_____

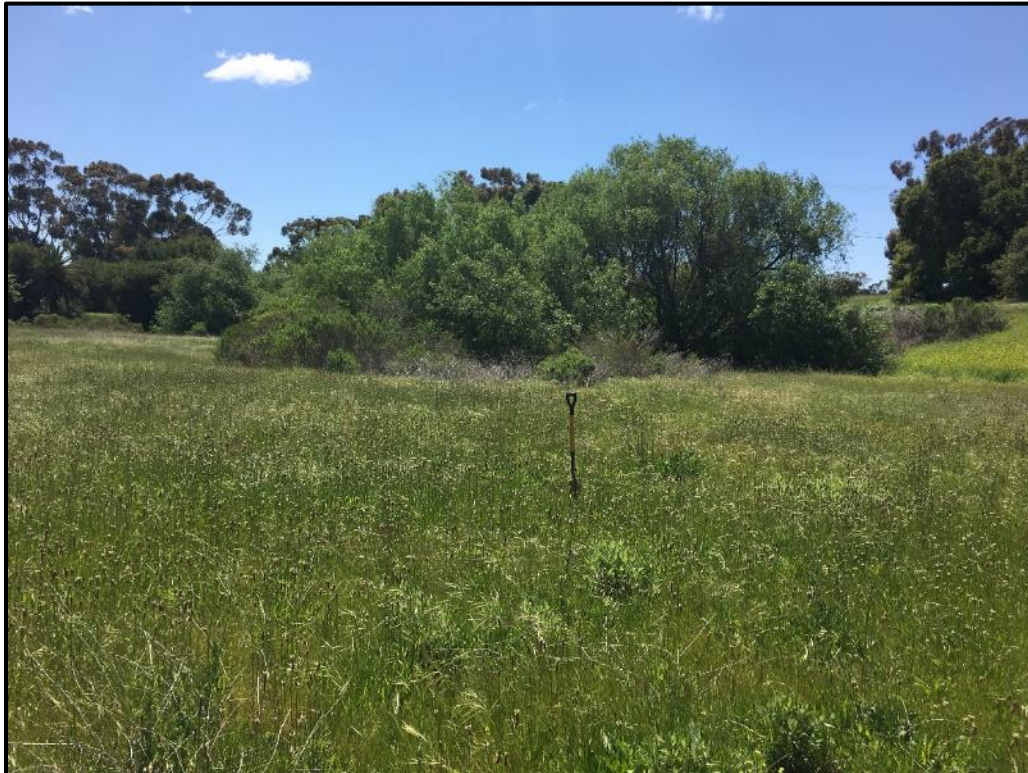
Photo 14. Sample Point SP09 located in the County wetland (Aspect: South). Photo taken April 18, 2018.
